**PHASE 1A LITERATURE SEARCH AND SENSITIVITY ASSESSMENT &  
PHASE 1B ARCHAEOLOGICAL FIELD RECONNAISSANCE SURVEY  
DUTCHESS SHEPHERD BULKELEY SCHOOL PROJECT**

6 MULBERRY STREET  
VILLAGE OF RHINEBECK, DUTCHESS COUNTY, NEW YORK

MARCH 2023

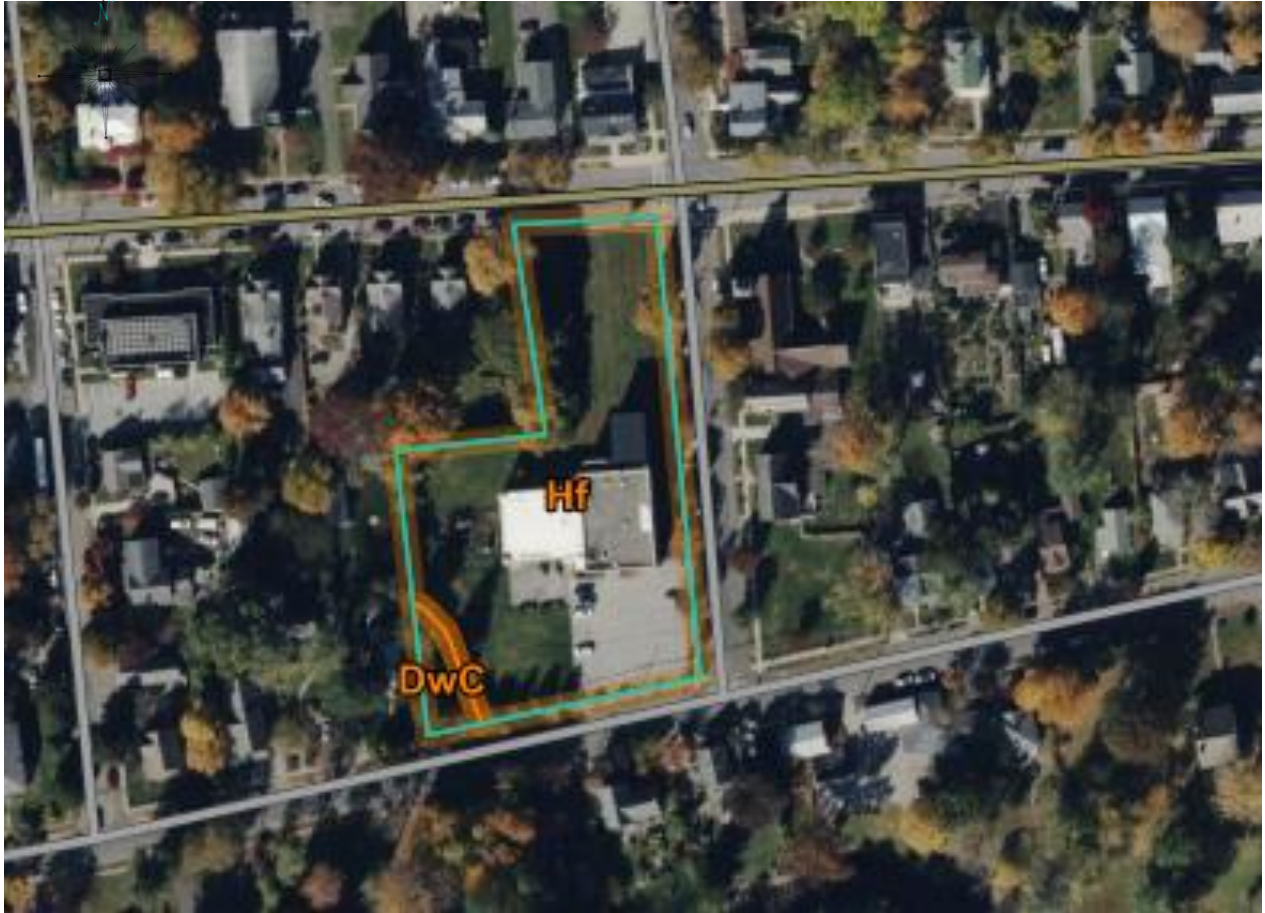
Figure 3: Aerial Image showing soil units within the Project Parcel. (Source: Natural Resources Conservation Service.) Scale: 1"=150'.

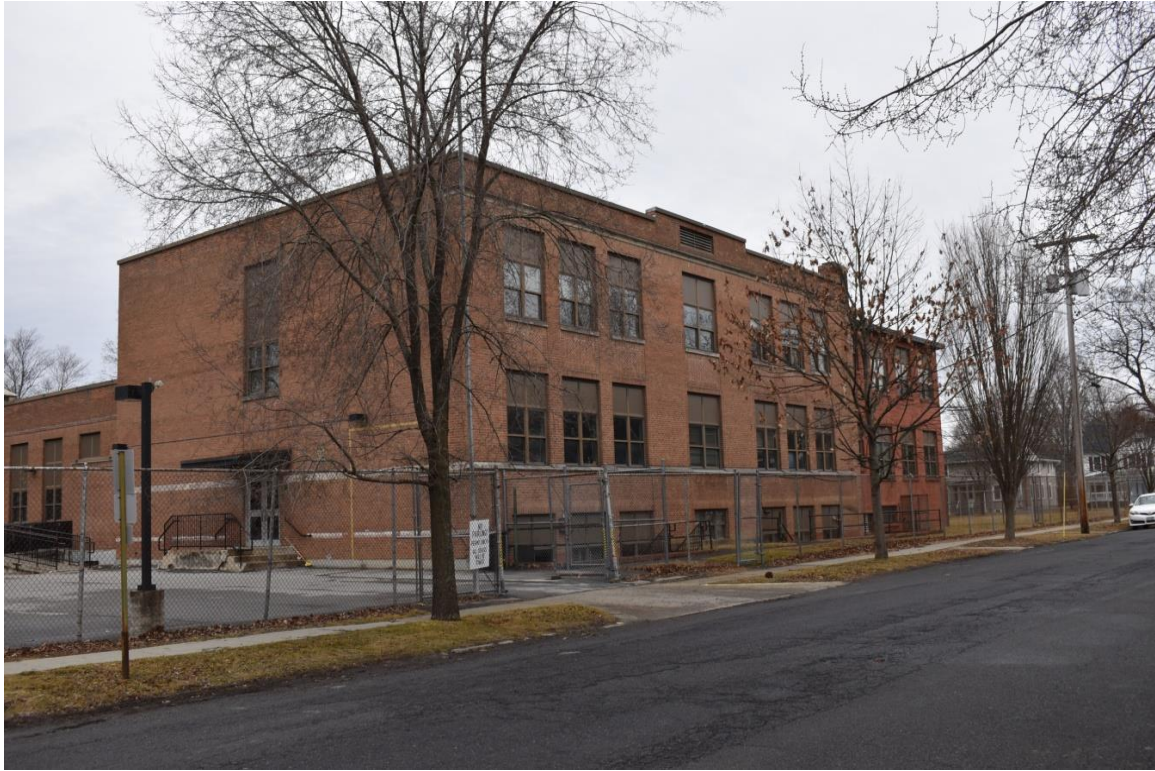
Photo 1: The former Bulkeley School is located in the center of the Project Parcel. View to the northwest.

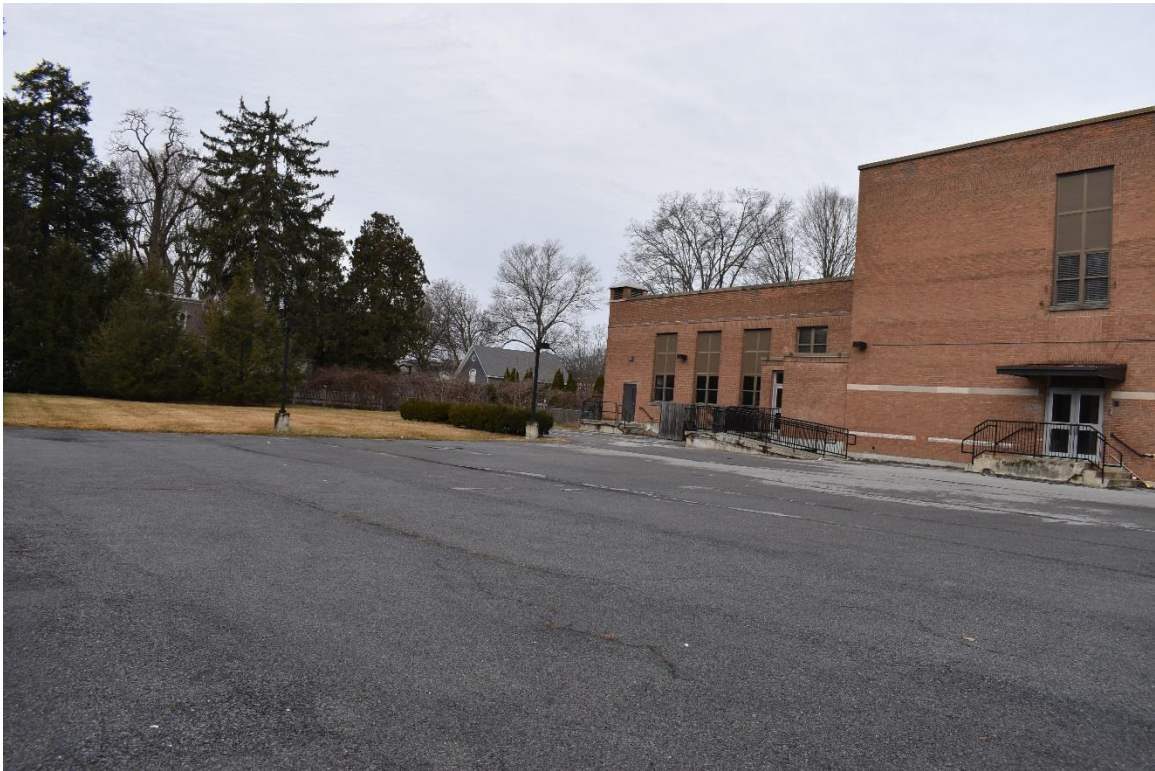
Photo 2: The southern portion of the Parcel contains an asphalt covered parking lot. View to the northwest.

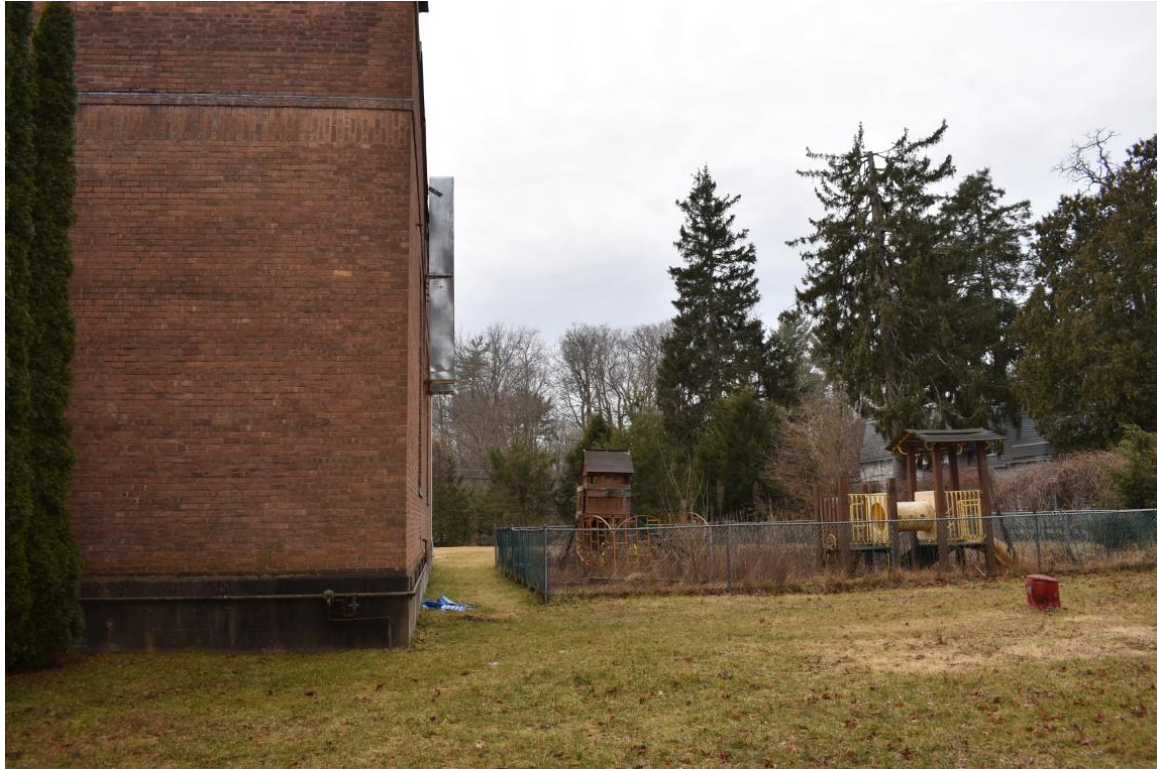
Photo 3: Buried utilities and a playground are in the western portion of the parcel. View to the south.

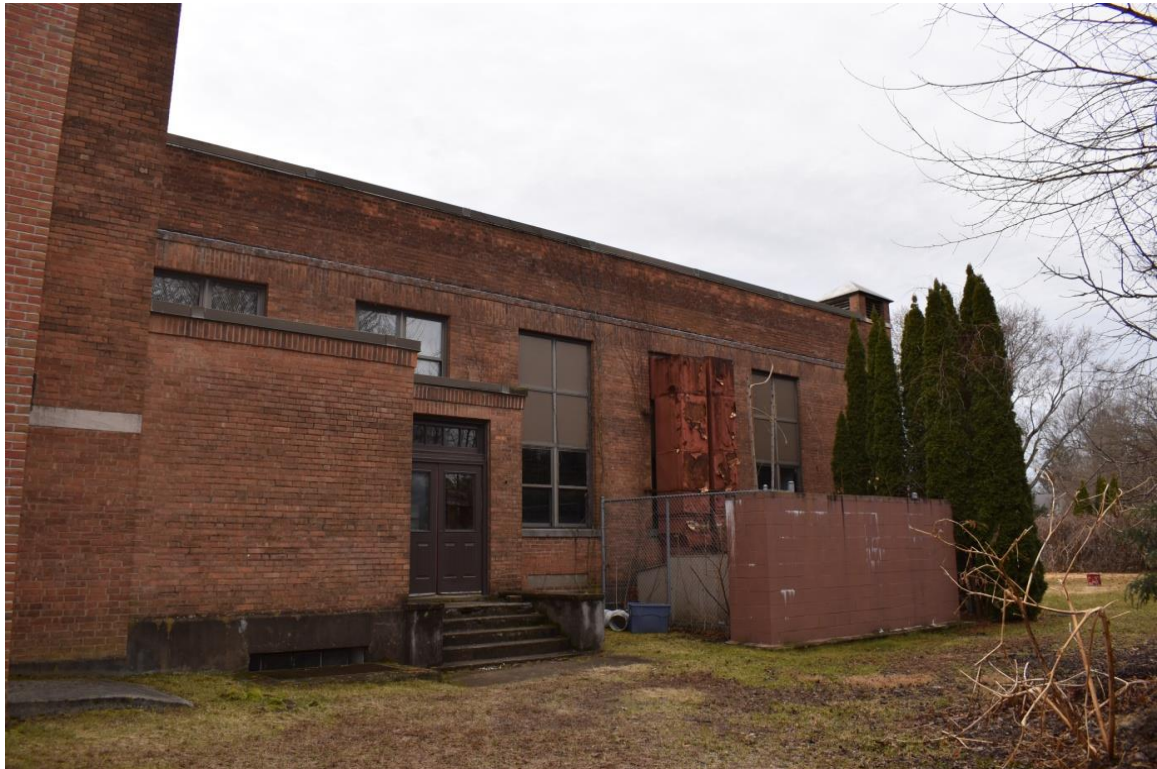
Photo 4: Buried utilities and equipment are located on the northern side of the school building. View to the southwest.

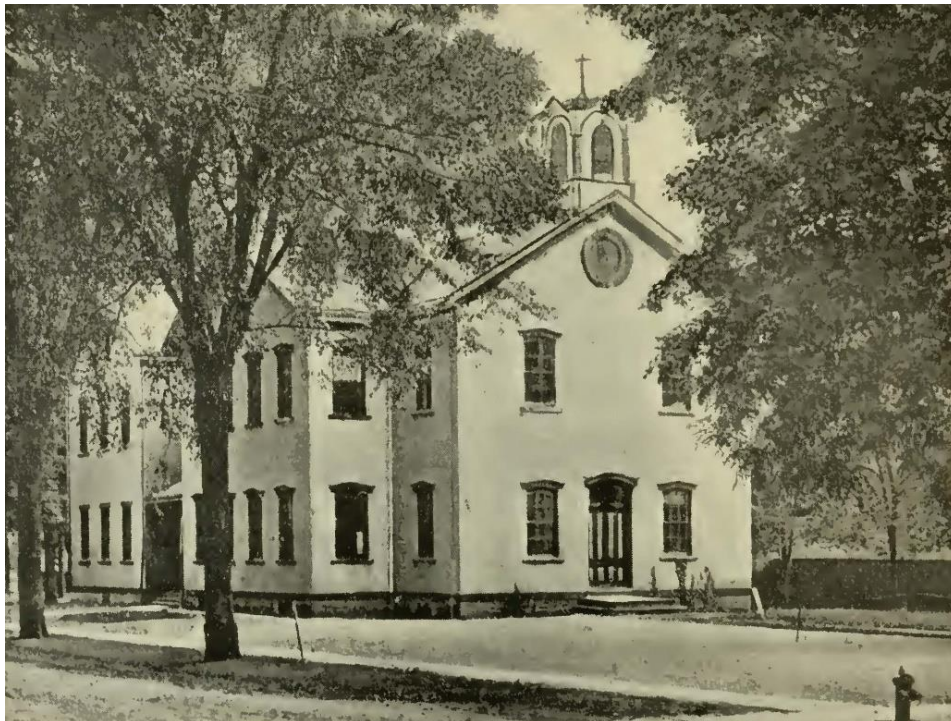
Figure 5: Image of the Bulkeley School with southern addition. Circa 1908. (Source Morse 1908).

The Sanborn Fire Insurance Maps (Figures 10, 12-13) show that the addition was constructed on the southern side of the building. The building was expanded again in 1912, and is identified as the Rhinebeck High School. The additions were reportedly completed in 1903, 1911 and 1921 (Poughkeepsie Journal 1939a). On April 21, 1939 the "old wing" of the building burned down. The original portion of the building was destroyed along with the heating plant for the newer portions of the building. The fire doors protected the newer portions of the school (Poughkeepsie Eagle News 1939a) Adolph Knappe was hired by the school district to design the improvements and renovations (Poughkeepsie Eagle News 1939b). The building was not immediately rebuilt, as plans were in place to centralize the district, which occurred in 1941. The Rhinebeck District purchased a 28-acre site, and began making improvements for a new school building. (Poughkeepsie Journal 1949). In the late 1940's the village residents rejected plans to build a new school building, rather than improve the Bulkeley school building (Poughkeepsie Journal 1948). The 1940 aerial image (Figure 14) shows that between 1912 and 1940 the footprint of the building changed, with the 1921

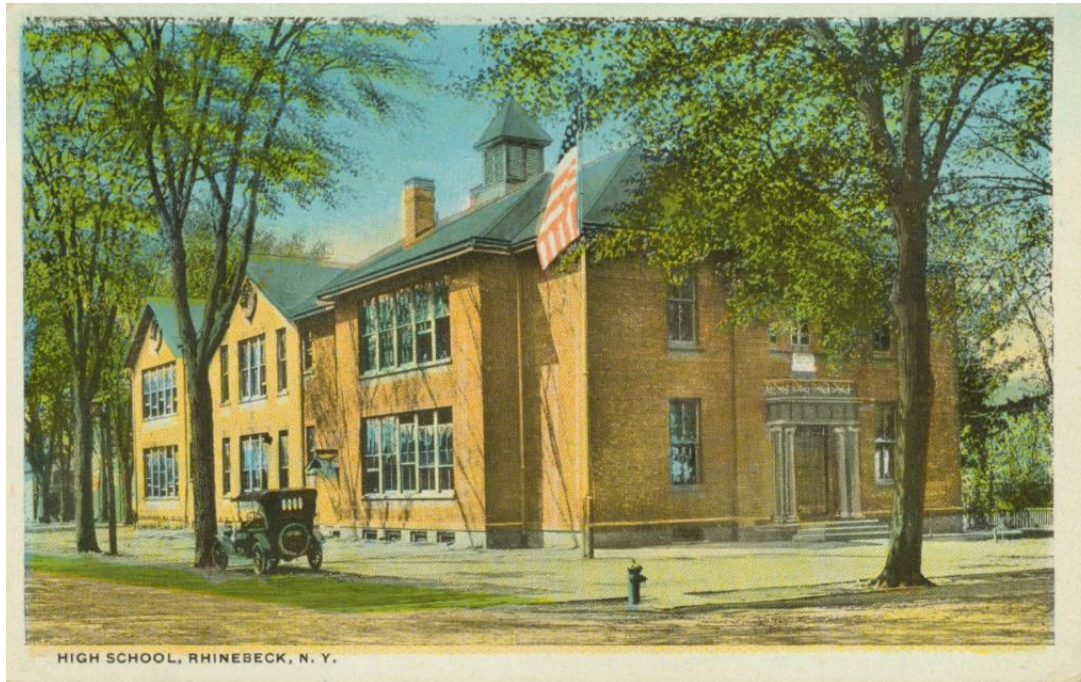
Figure 6: Post card of the school building c. 1928. (Source: New York Heritage digital collections). This image shows the additions from the early 1900s, and the northern addition completed by 1912.

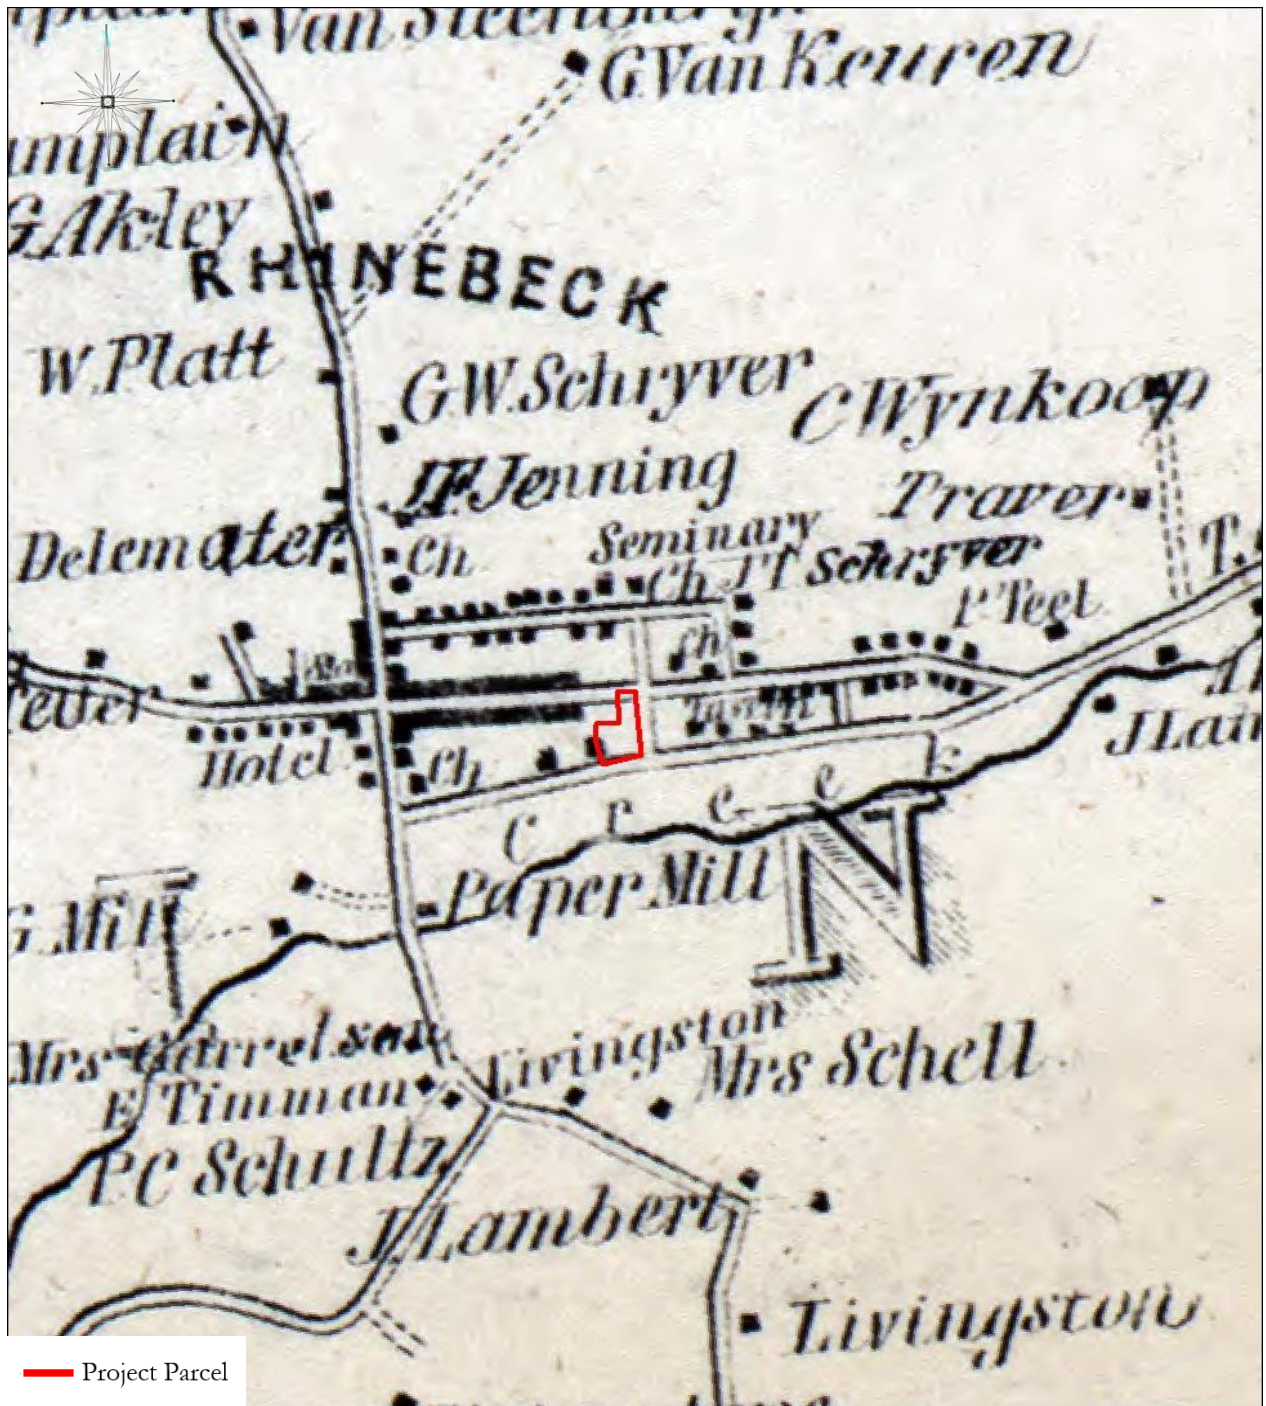
Figure 7: 1850 J.C. Sidney *Atlas of Dutchess County, New York*. (Source: Library of Congress) Scale: 1" = 1000'.

The earliest map included in this report is the 1850 *Atlas of Dutchess County, New York*. No structures are shown within the Project Parcel, although there is a building located on the western boundary. The village is densely settled, but no details are shown for the buildings except the tavern and churches within the villages.

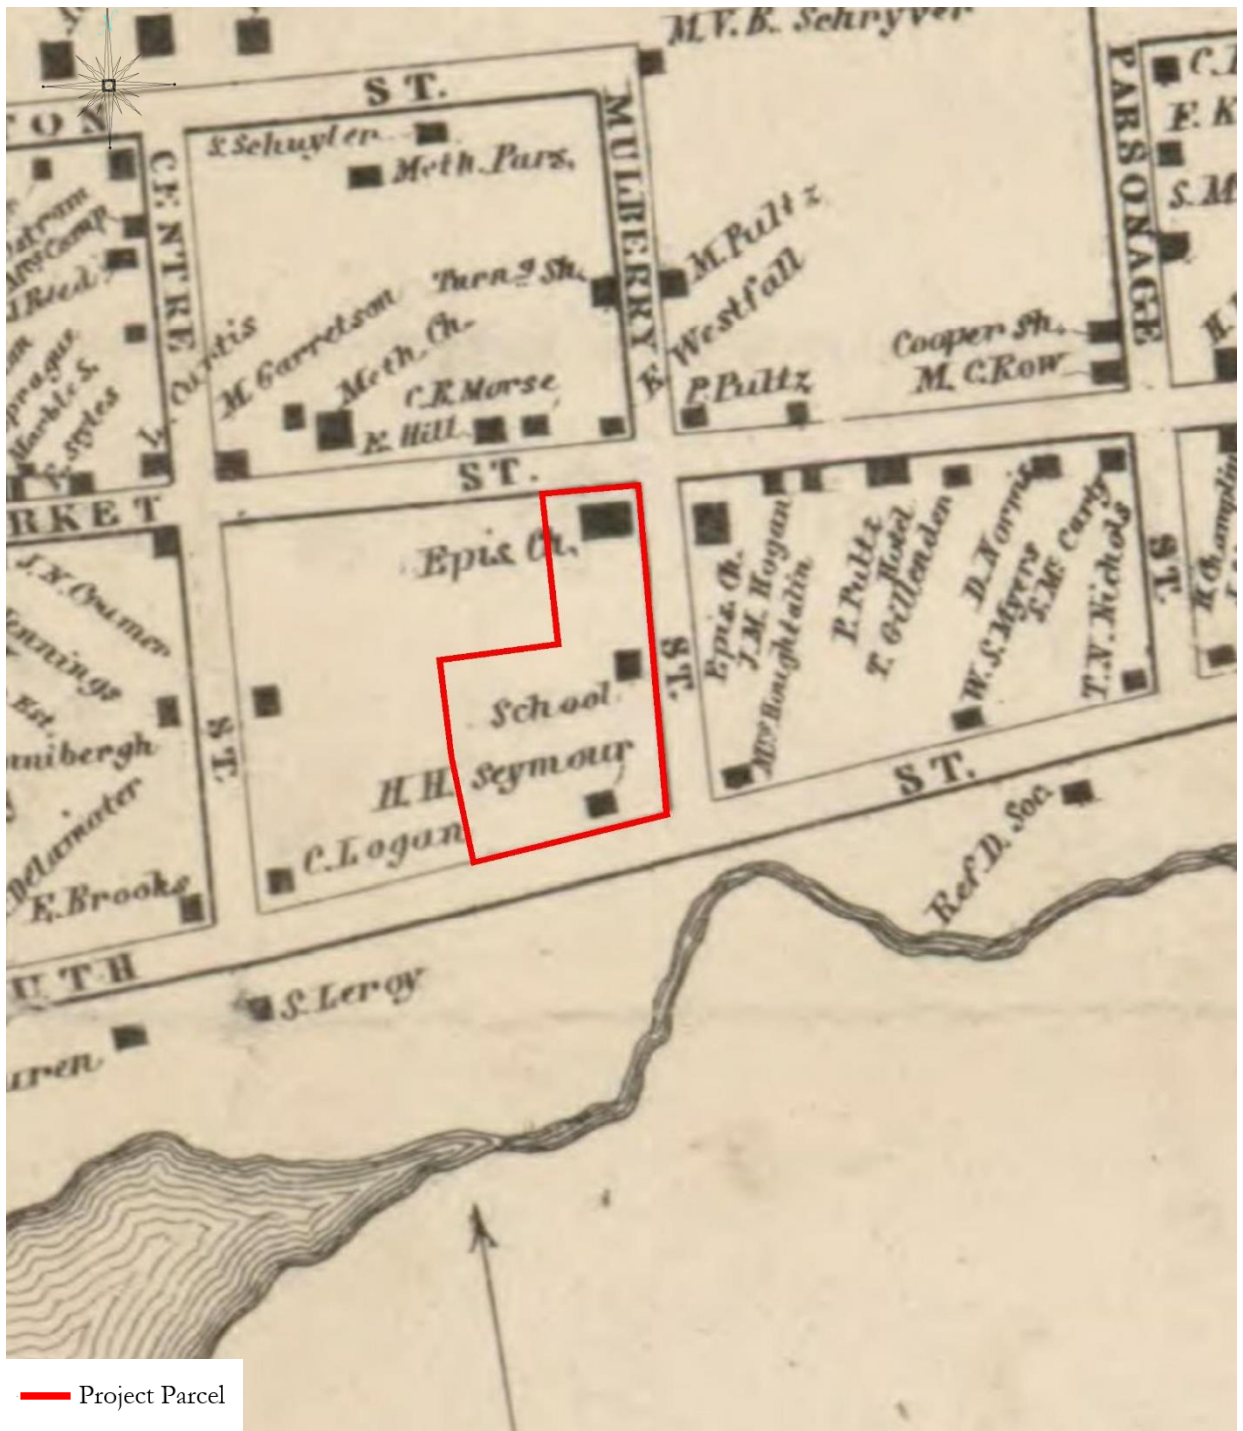
Figure 8: 1858 J. E. Gillette. *Map of Dutchess County, New York*. (Source: Library of Congress) Scale: 1" = 200'

The second map consulted for this report is the J.E. Gillette *Map of Dutchess County New York* published in 1858. This map shows three buildings within the boundaries of the Project Parcel. The Seymour residence is located near South Street, the school is in the center of the parcel near Mulberry Street, and a building identified as the Episcopal Church, at the intersection of Market Street and Mulberry Street.

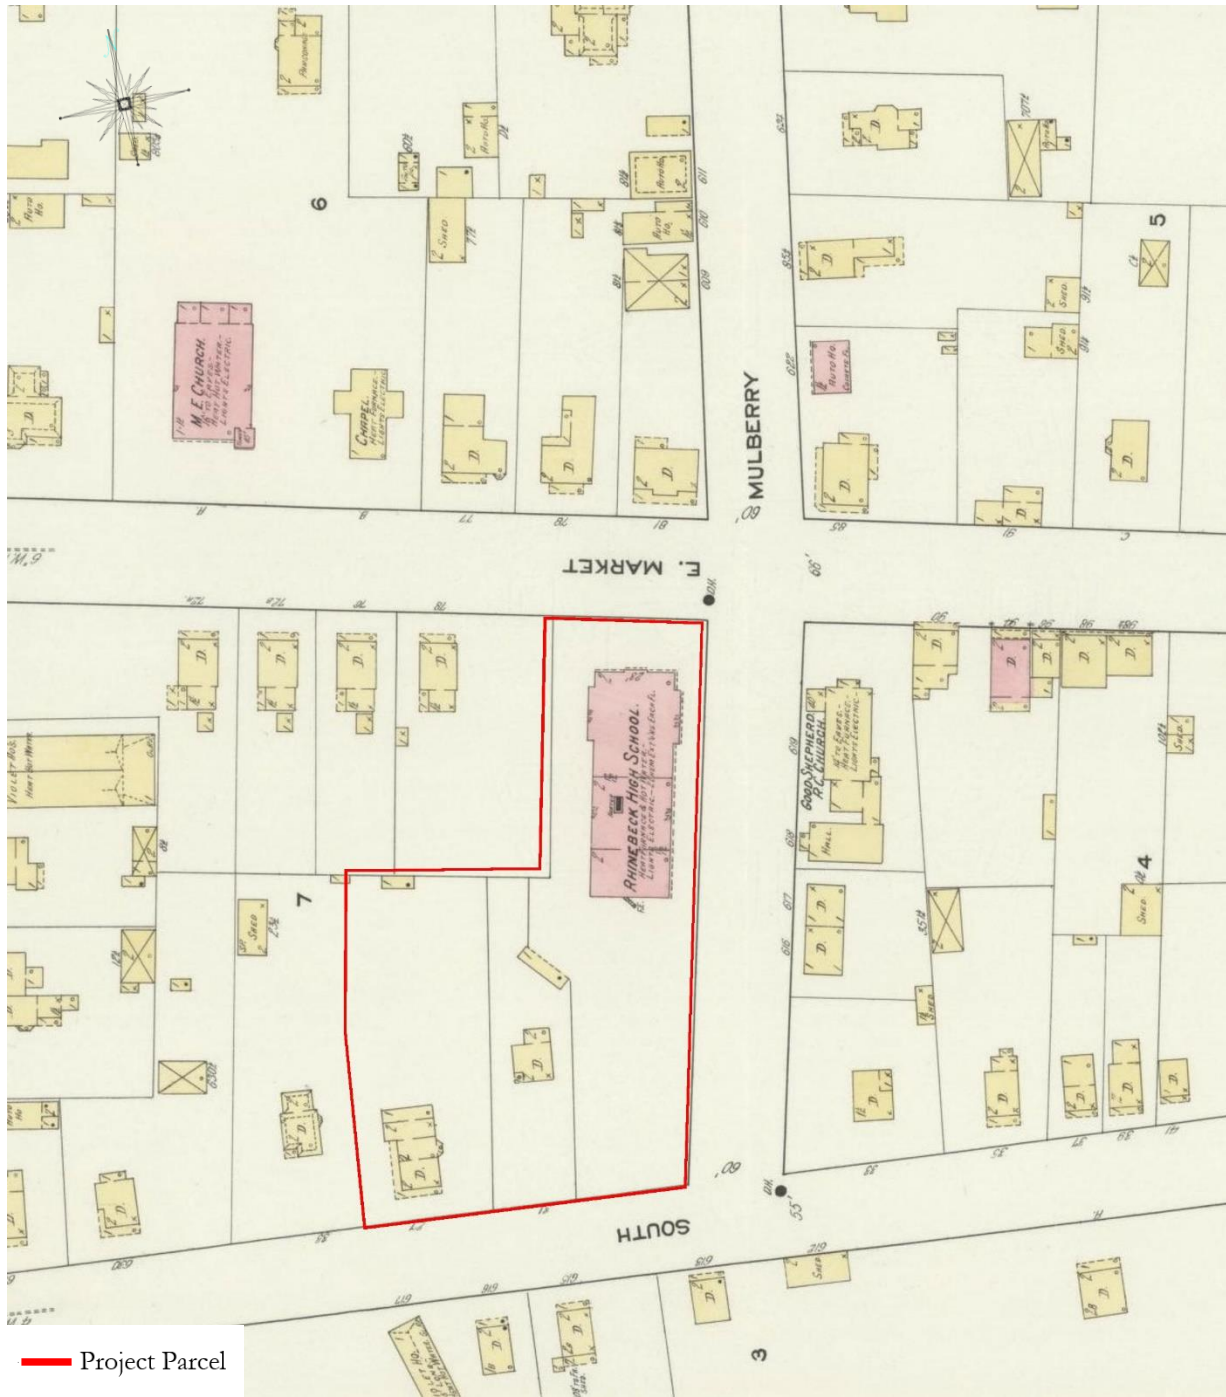
Figure 13: 1912 Sanborn Fire Insurance Map. *Village of Rhinebeck N.Y.* (Source: Library of Congress) Scale: 1"=1245'.

By 1912 an addition has been constructed on the northern side of the original school structure. The 1868 structures has been incorporated into the larger brick high school building. To the south and southwest, the residential structures are shown on their own lots. The school is two stories in height, and is identified as being fully electric with a furnace and hot water plant.

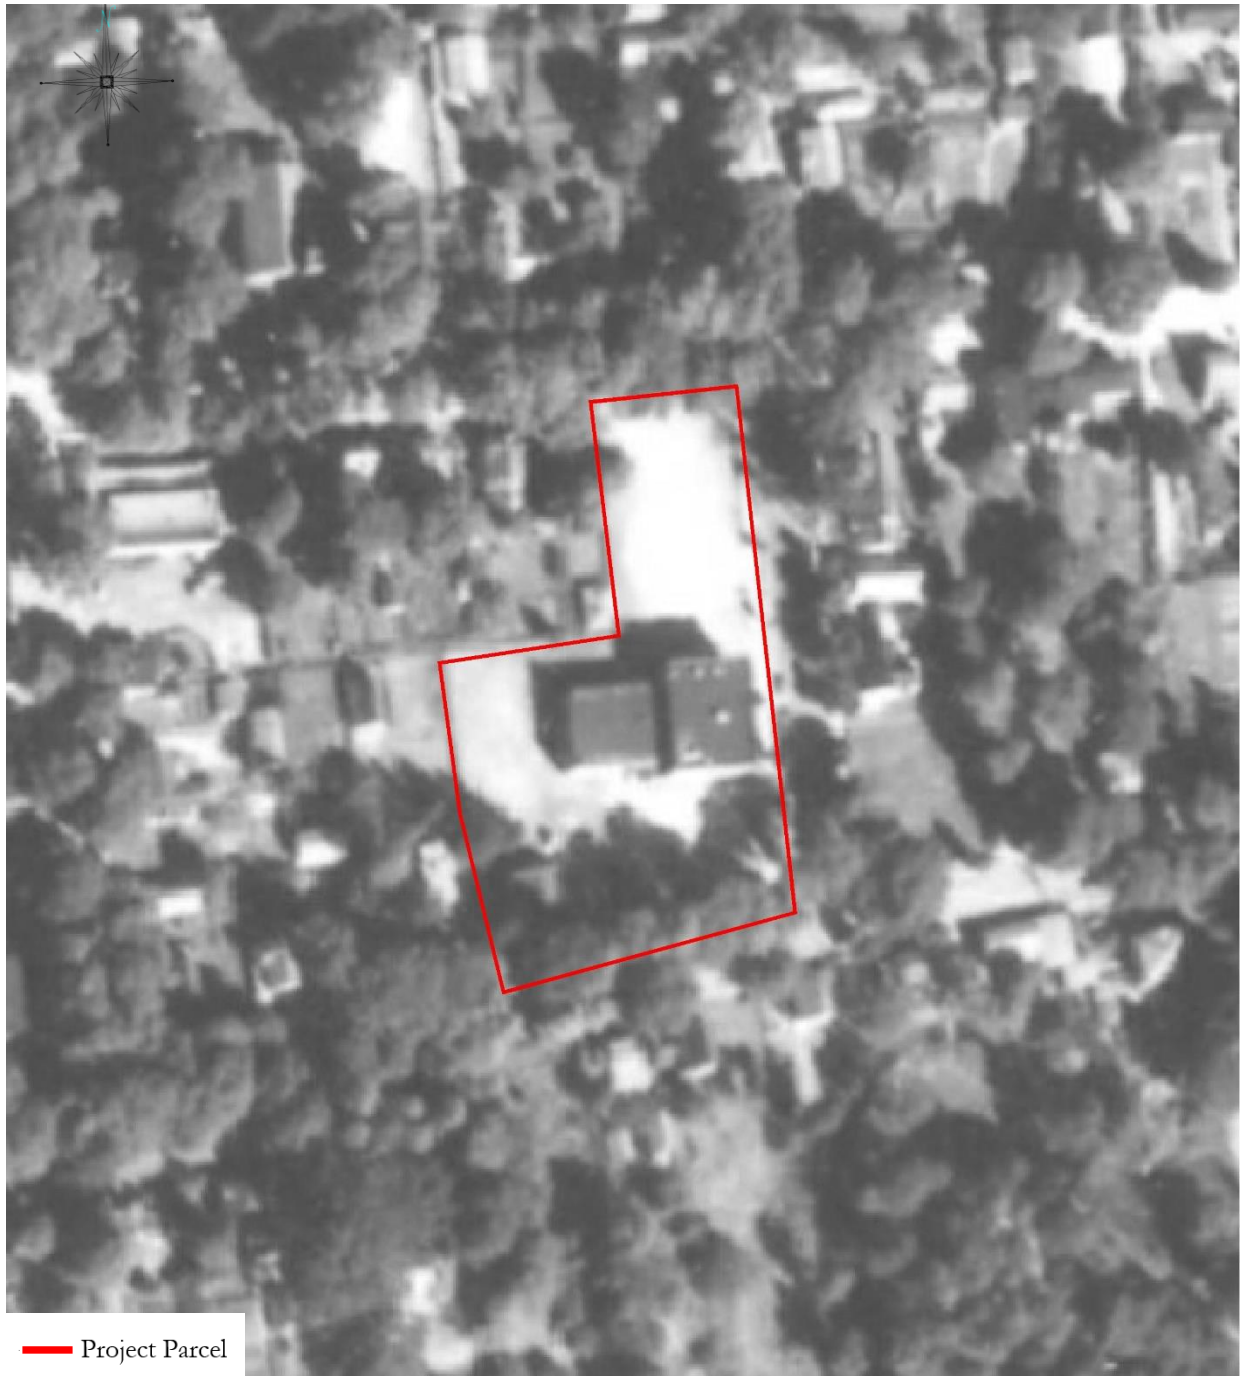
Figure 14: 1940 Aerial image. Village of Rhinebeck, Dutchess County. (Source: Dutchess County Parcel Access) Scale: 1"=130'.

The 1940 aerial image indicates that dramatic changes have taken place to the school building and surrounding property. The structures shown consists of the circa 1905 addition, with a new addition (c. 1921) located on its western side. A newspaper article identifies three additions, the 1903, 1912 and a 1921. The northern portion of the parcel has been graded and leveled, likely the result of the burned portions of the building being removed. The residential structure in the southwestern corner of the Parcel is still present. Due to the vegetation and tree cover, it is unclear if the second residential building is still present.

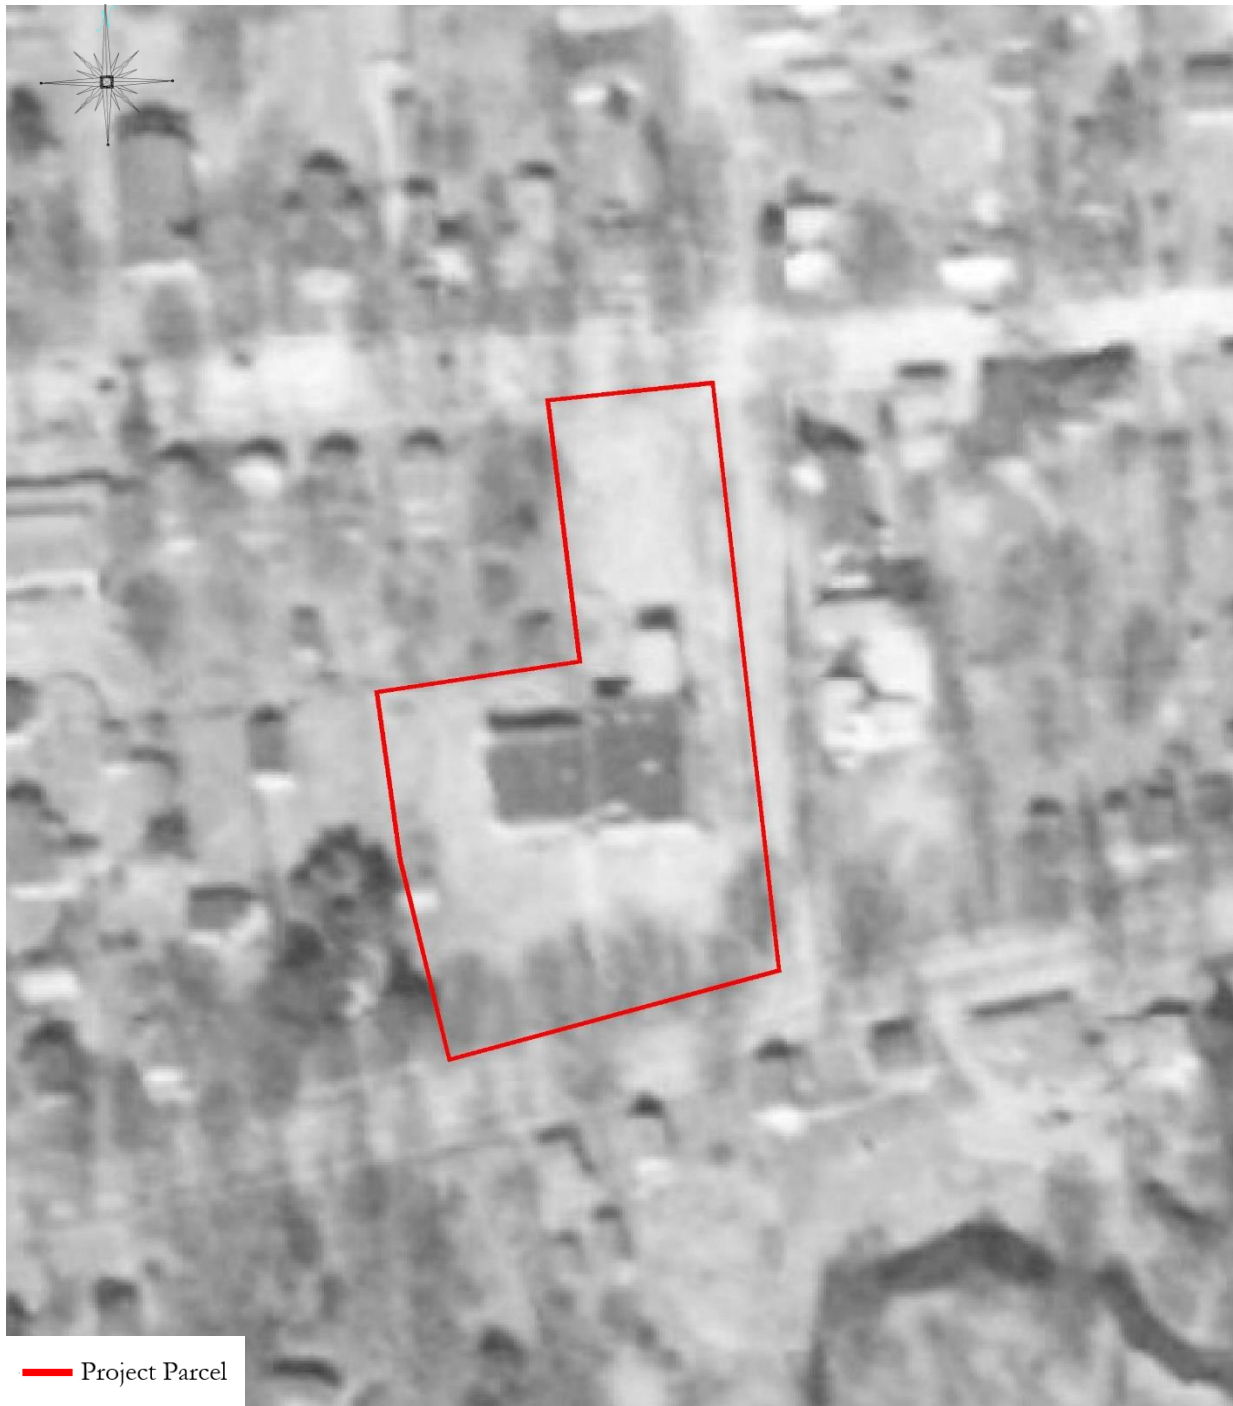
Figure 15: 1955 Aerial image. Village of Rhinebeck, Dutchess County. (Source: Dutchess County Parcel Access) Scale: 1"=120'.

The 1955 aerial image indicates shows that a small addition has been constructed on the northern side of the building. The residential structures in the southern and southwestern portions of the Parcel have been removed, and the area graded as lawn.

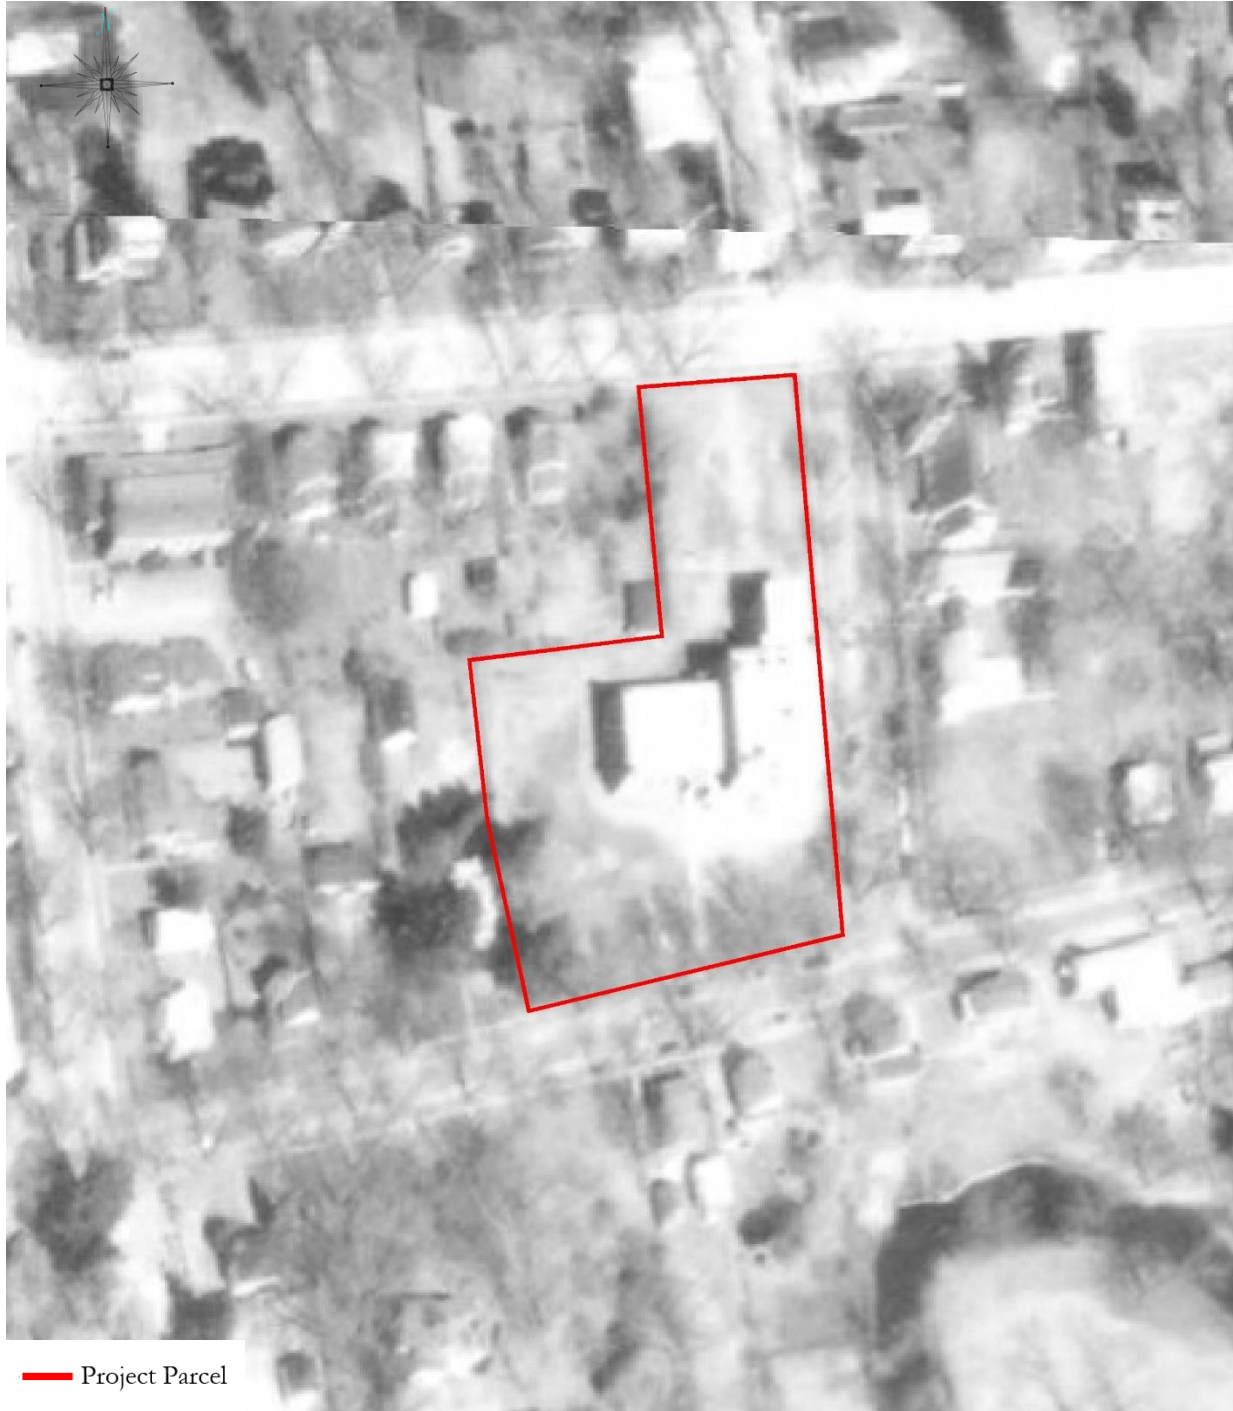
Figure 16: 1970 Aerial image. Village of Rhinebeck, Dutchess County. (Source: Dutchess County Parcel Access) Scale: 1"=115'.

The 1970 aerial image shows that there have been few changes to the parcel. The southern side of the building appears to be gravel or recently graded.

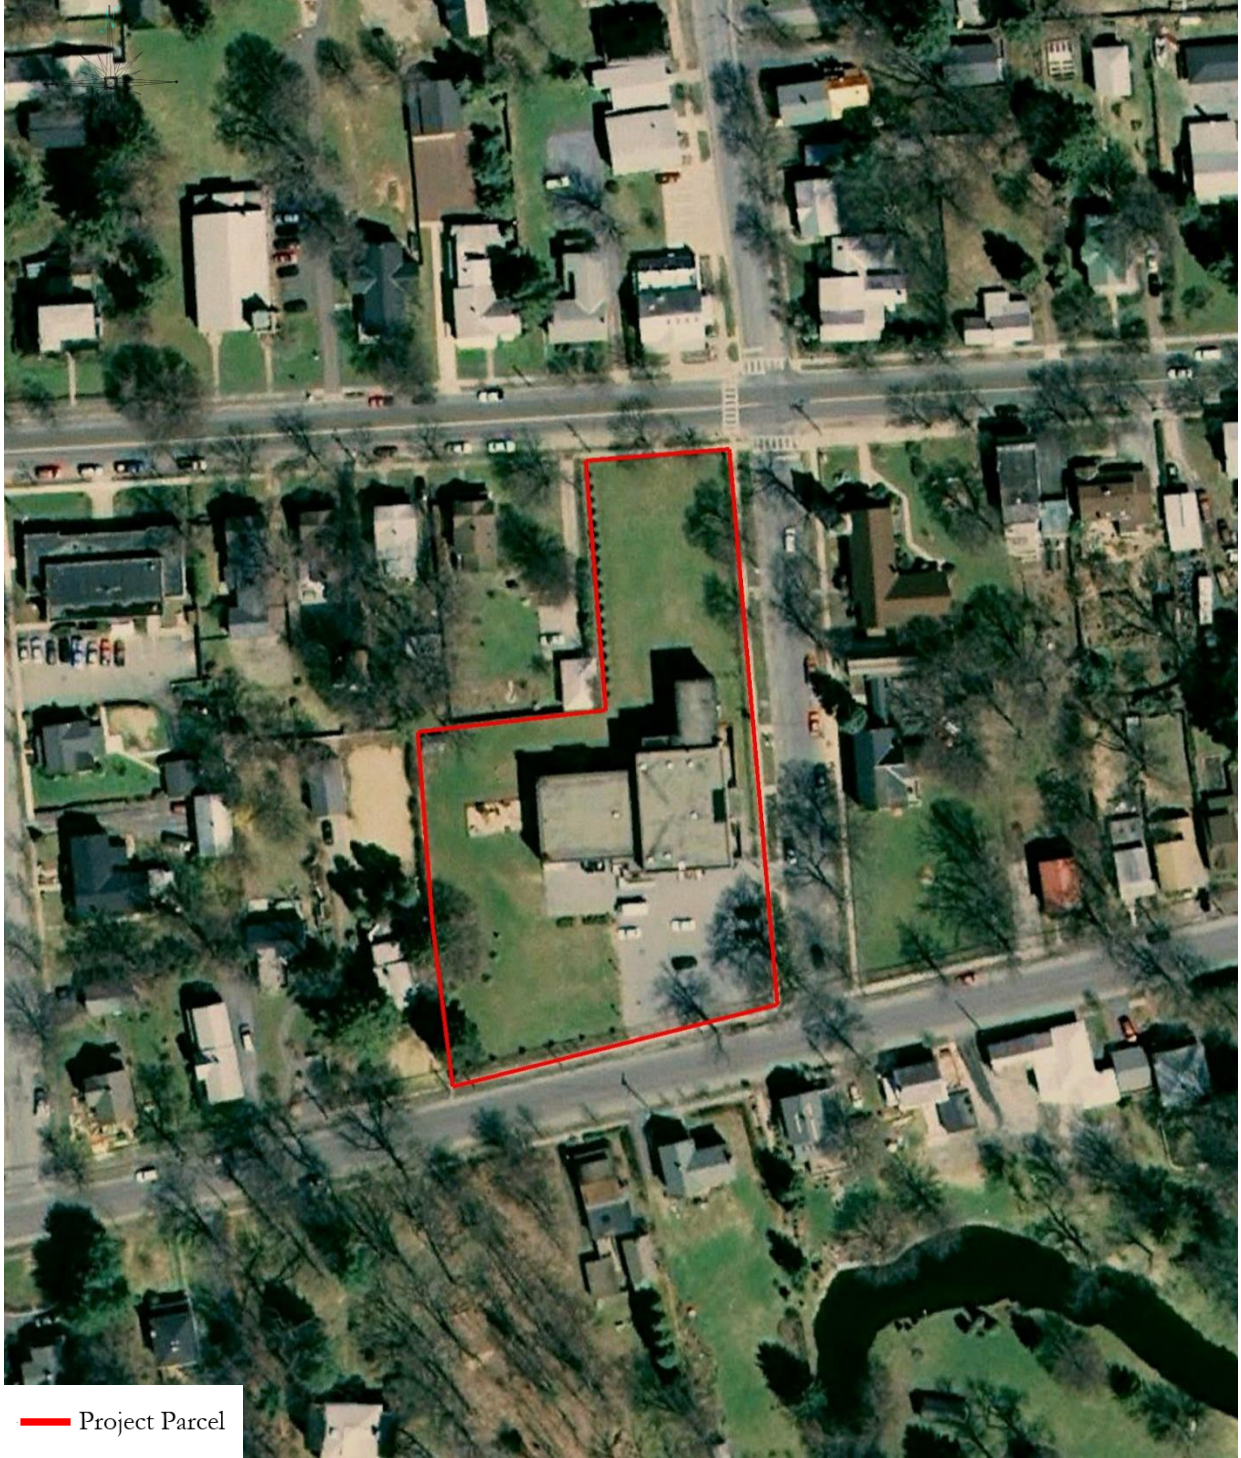
Figure 17: 2004 Aerial image. Village of Rhinebeck, Dutchess County. (Source: Dutchess County Parcel Access) Scale: 1"=135'.

The 2004 aerial image shows that the southern portion of the Parcel is covered with asphalt, and utilized as a parking lot. A playground has been constructed on the western side of the building.

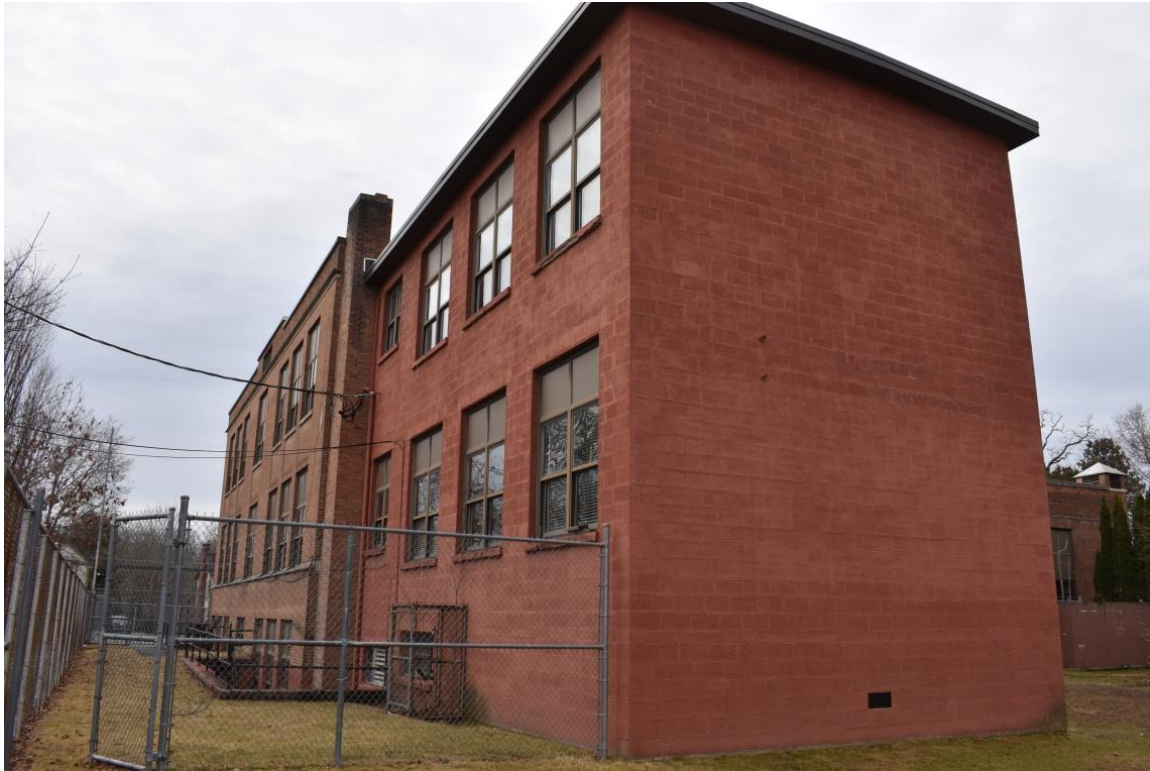
Photo 5: The northern side of the building is constructed of cinderblock, and painted red. View to the south.

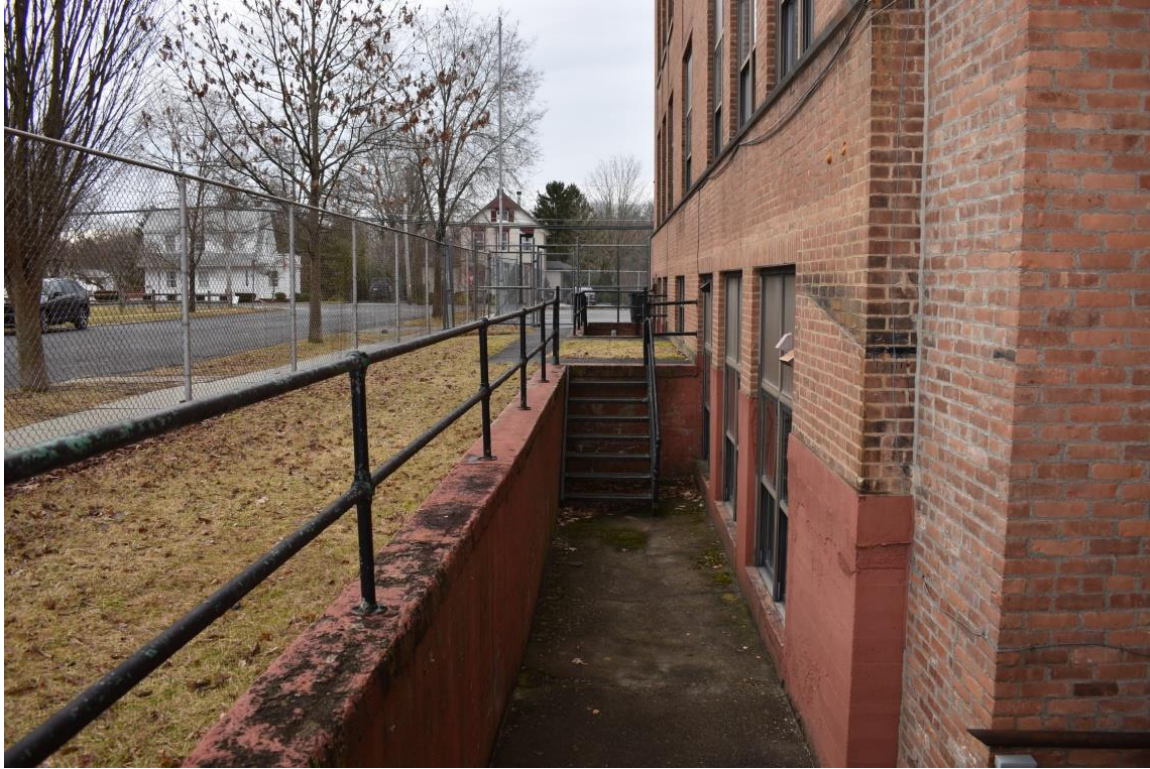
Photo 6: Access points on the eastern side of the building are below grade. View to the south.

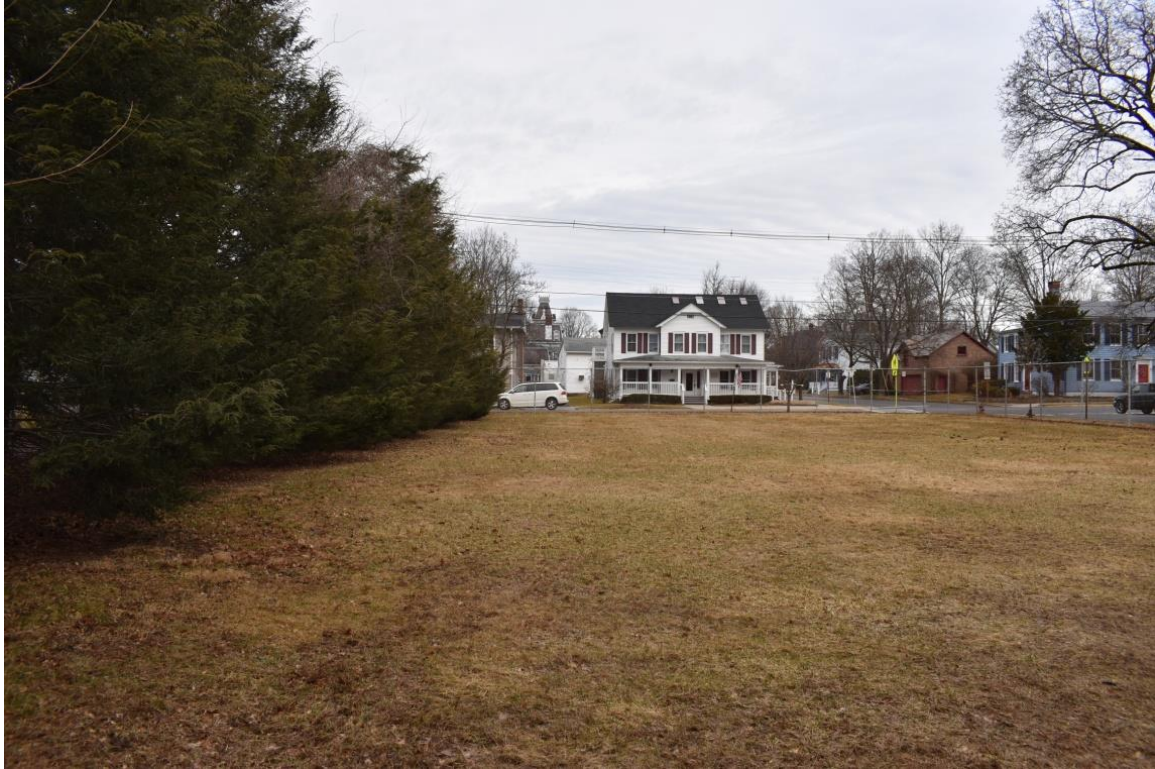
Photo 8: The northern portion of the parcel consists of mown lawns. View to the north.
