**PHASE 1A LITERATURE SEARCH AND SENSITIVITY ASSESSMENT &  
PHASE 1B ARCHAEOLOGICAL FIELD RECONNAISSANCE SURVEY  
DUTCHESS SHEPHERD BULKELEY SCHOOL PROJECT**

6 MULBERRY STREET  
VILLAGE OF RHINEBECK, DUTCHESS COUNTY, NEW YORK

MARCH 2023

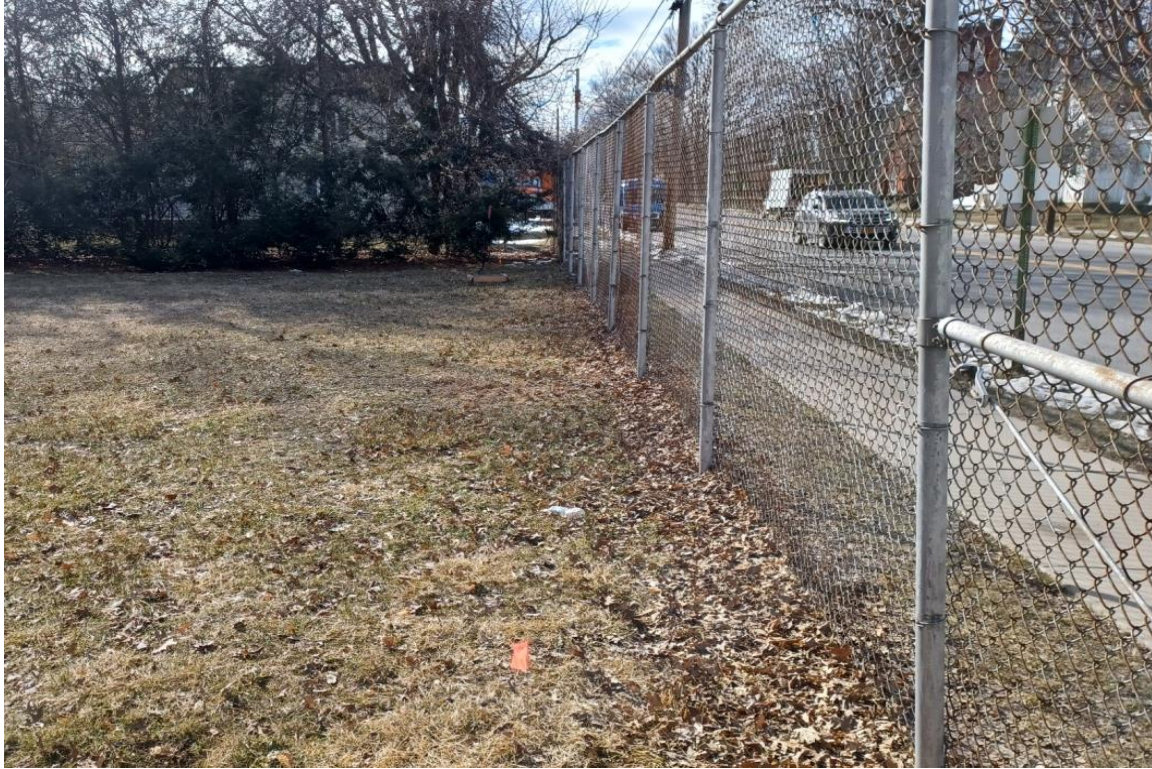
Photo 9: Transects 1 and 2 began near East Market Street. View to the west.

Testing began in the north of the Project Parcel, near the corner of Mulberry and East Market Street. This area, consisting of Transects 1 and 2, was previously cleared and contains a packed gravel road, leach field, and large lawn area. The 1940's aerial (figure x) shows that the ground surface has been graded. Soils in this area consisted of brown gravelly silt loams or gravelly loam overlaying a dark yellowish brown gravelly silt loam. Near the schoolhouse, an intermediate layer of dark brown gravelly loam was found under the brown gravelly silt loam and overlying a yellowish brown clay with packed gravel. Plastic, brick fragments, coal, coal slag and window glass fragments were recovered and discarded.

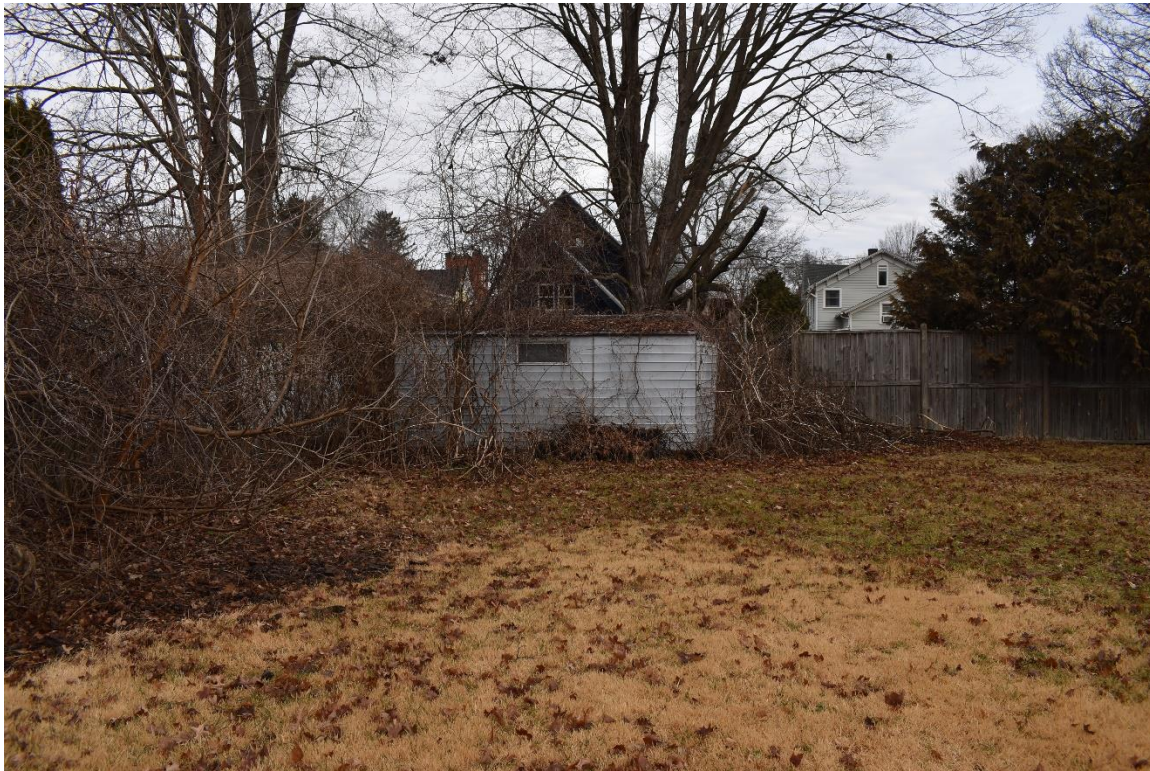
Photo 12: A shed is located in the northwestern portion of the Project Parcel. View to the north, of the location of TR 5.

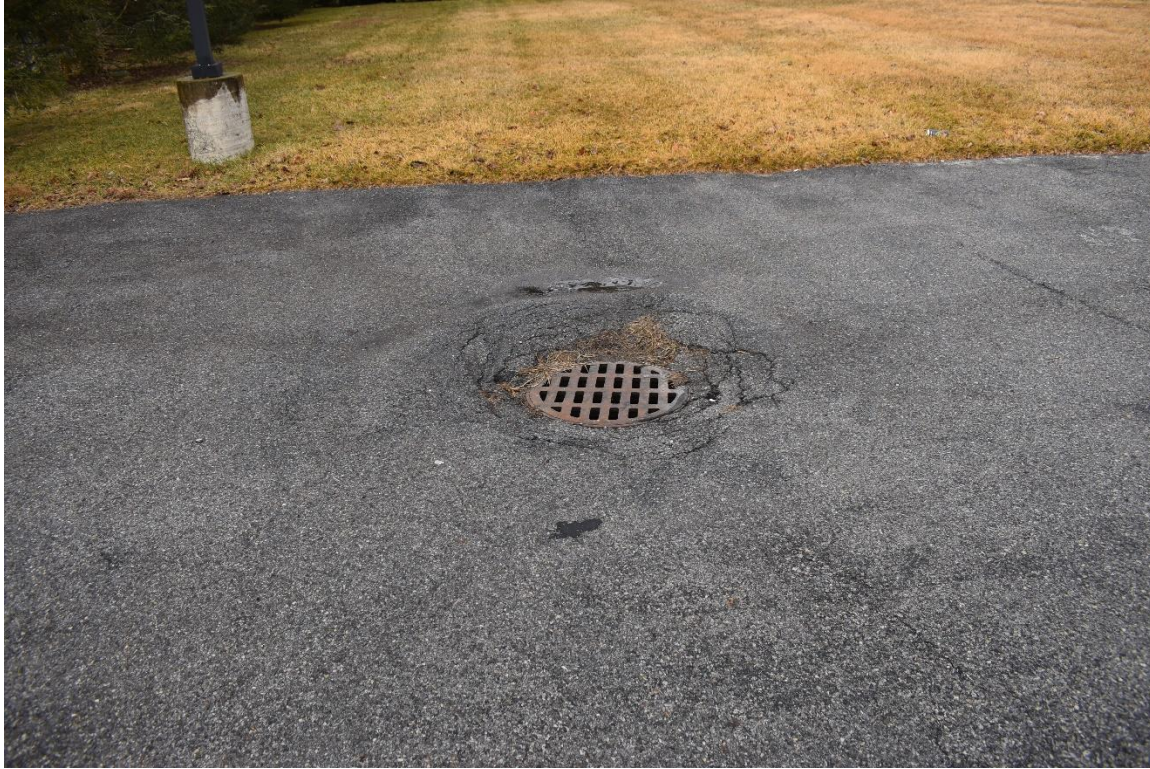
Photo 13: Stormwater drains are located in the parking area, in the southern portion of the Parcel. View to the west.

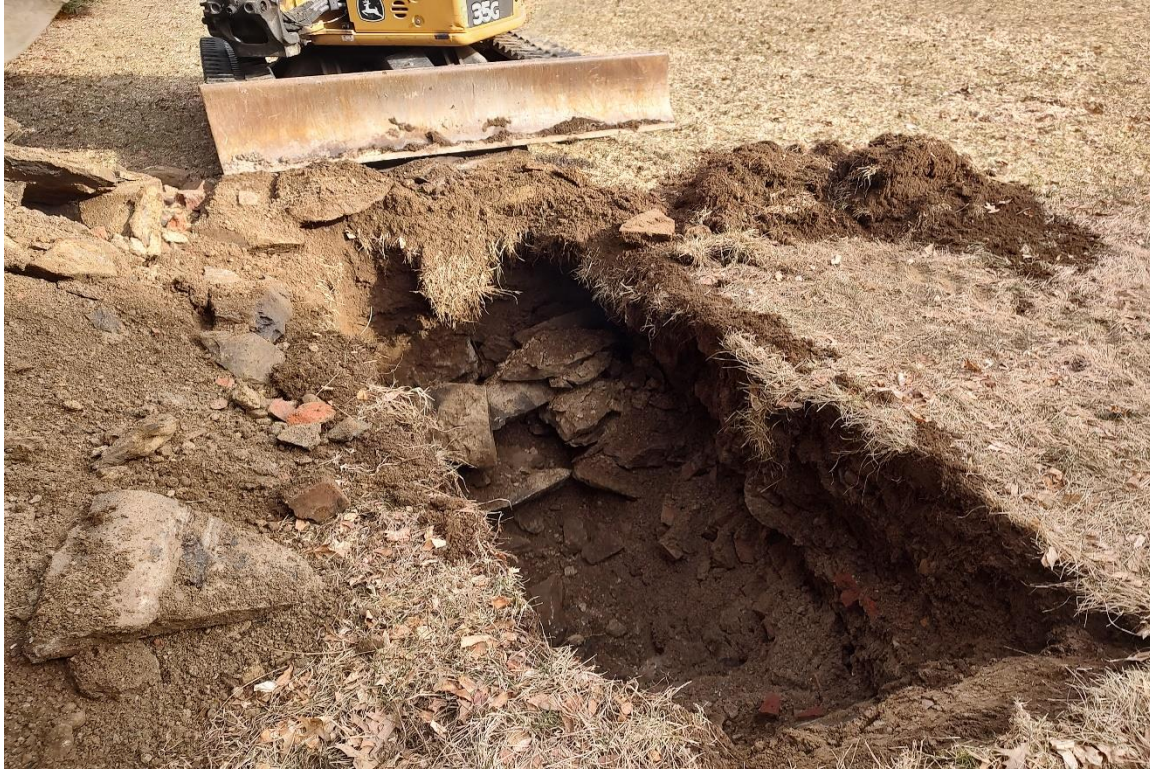
Photo 14: Deep tests, completed by the owner for proposed septic systems show extensive disturbance and building debris to the north of the school building.
